APATBANDHAVA

-THE ASH LEAKAGE DETECTOR

THE HIGHFLYERS

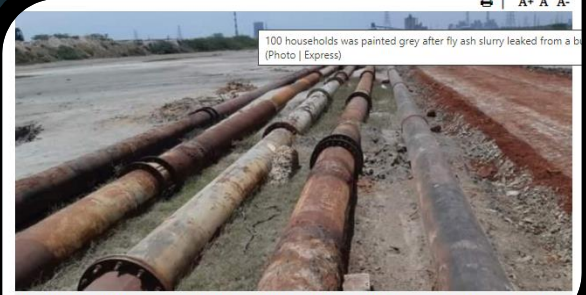
100 households was painted grey after fly ash slurry leaked from a busted pipeline of the North Chennai Thermal Power Station. (Photo | Express)

- There have been 76 major fly ash accidents across India in the last 10 years and around 17 incidents last year alone.
- -These 17 were reported from Nagpur, Madhya Pradesh, Odisha, Chhattisgarh, Jharkhand, West Bengal and Maharashtra.
- Regions such as Chhattisgarh's Korba, and north -Chennai's Seppakkam and Ennore, witnessed multiple accidents related to fly ash mismanagement.
- -During all these occurrences, death was inevitable alongside some serious damage to the vicinity.
- -Hundreds of workers who cleaned up the fly ash spill are now sick and dying. One reason for increase in recent years could be on account wear and tear of Old pipelines

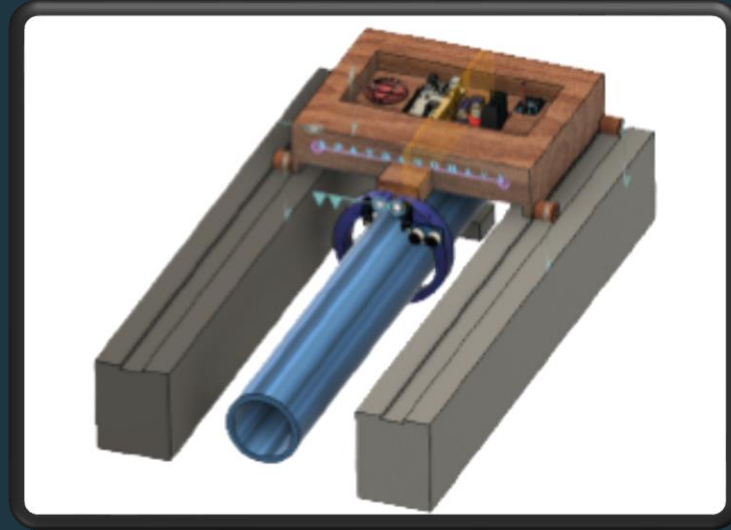
CAD MODEL

- Here is the CAD model of APATBANDHAVA.

- ❖ This cobot ensures that there are no leakages left undetected in the industries.
- ❖ This cobot uses line follower mechanism for its movement.
- ❖ The bot is installed with piezoelectric sensors that senses ash particles that would lead to a leakage.
- ❖ It is equipped with a buzzer that alerts the workmen when there's an accident additionally giving the exact location.
- ❖ It is equipped with ultrasonic sensors and servo motors which helps the bot to overcome obstacles by lifting its piezo wings.
